GRIEVES WOOLEN MILL  
ILO# 001091990  
MARSHALL COUNTY, IL  
IEPA 1230100009  
SF / HRS

# **CERCLA**

## **Integrated Site**

**Illinois Environmental  
Protection Agency**

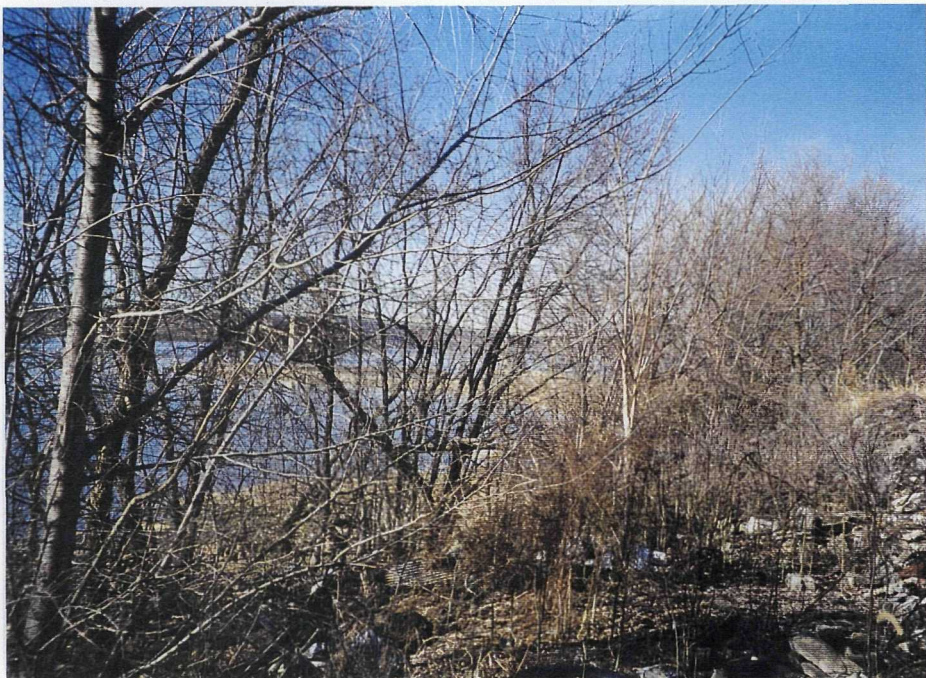
PICTURE TAKEN TOWARD  
the north.  
. Last in Panorama.  
.Shows edge of berm to rt.  
.Illinois River to Left.  
.Area between berm & River  
.is bluff & flood plain.  
.This area has scattered  
. through out.

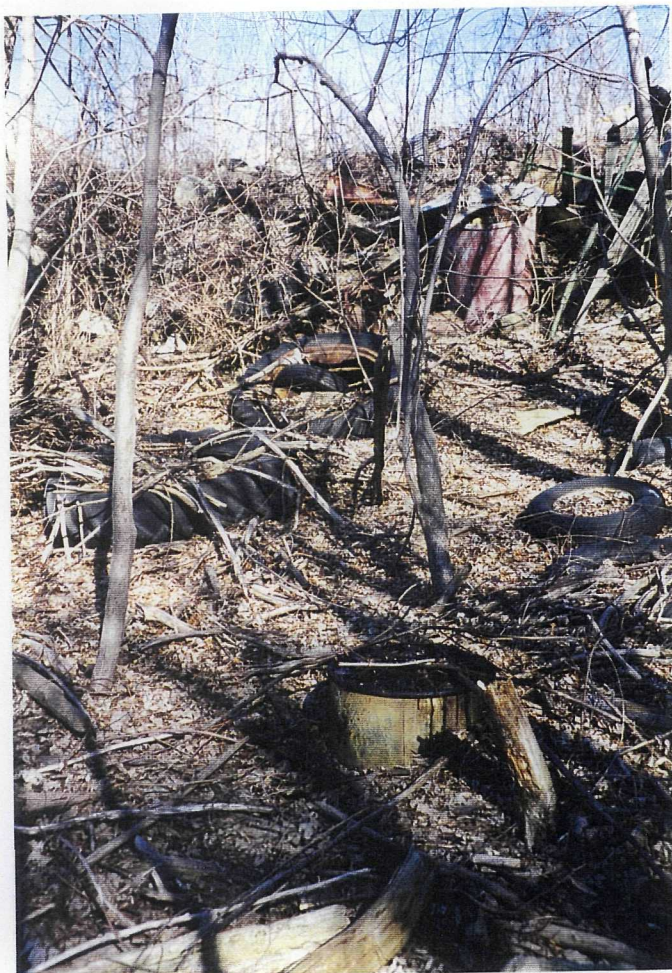
cinders and ash, building debris and scrap metal. Two drums with a tar like substance inside were observed. Several groundwater seeps were identified on the floodplain which flowed into the river.

PICTURE TAKEN TOWARD  
the east.  
.Photo of bluff from flood  
.plain. Shows barrels  
.and tires.  
.  
.

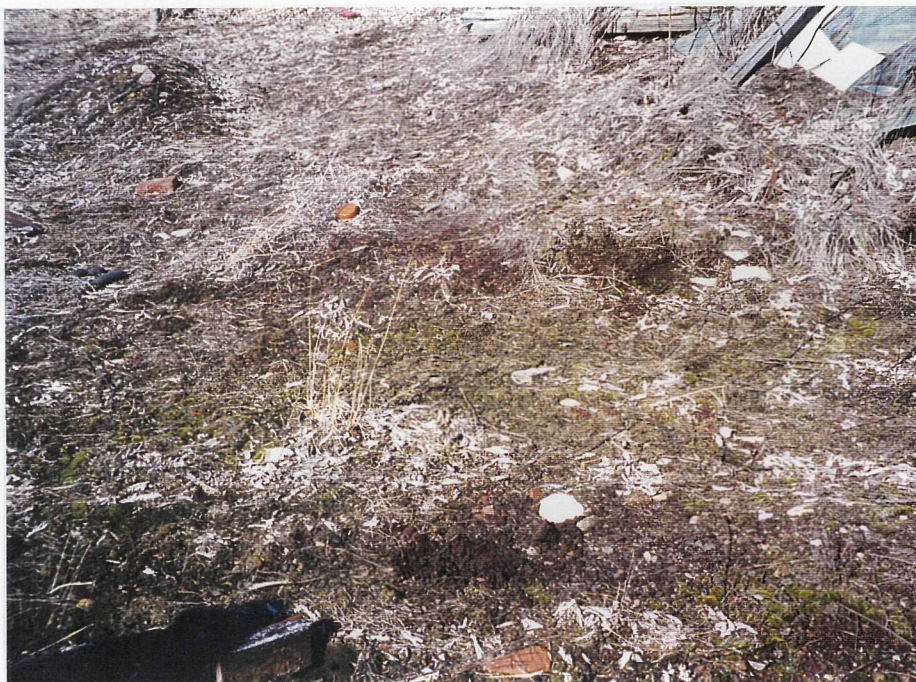
Two areas of discolored soil were observed on the upper north portion of the site. The first had a maroon color and coincided where transformer oils were allegedly burned near the old power plant. The second was yellow in color and located west of the picking room. A broken twelve inch tile line was observed alongside a large fuel tank in the southeast. The tile line may have been the drain pipe from the dye room. The fuel tank was uncovered and empty.

PICTURE TAKEN TOWARD  
the north.  
.Photo shows potentially  
.discolored soils.  
.

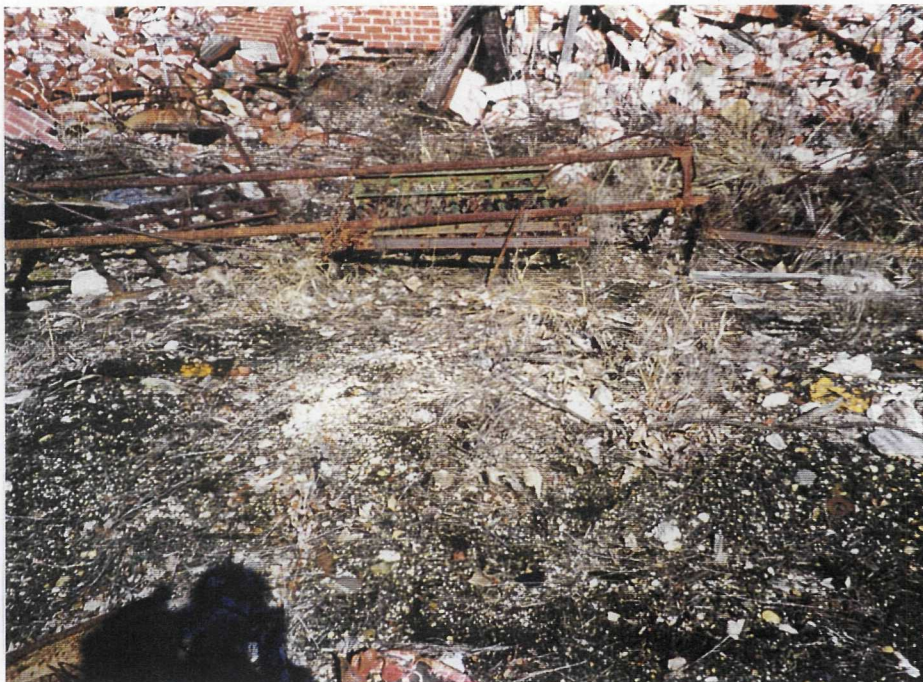
PICTURE TAKEN TOWARD  
the east.  
.Photo shows potentially.  
.discolored soils.  
.  
.  
.
